ANGKOR VAT

INDIA'S CONTRIBUTION IN CONSERVATION

MEMOIRS OF THE
ARCHAEOLOGICAL SURVEY OF INDIA
NO. 91

B. NARASIMHAIAH

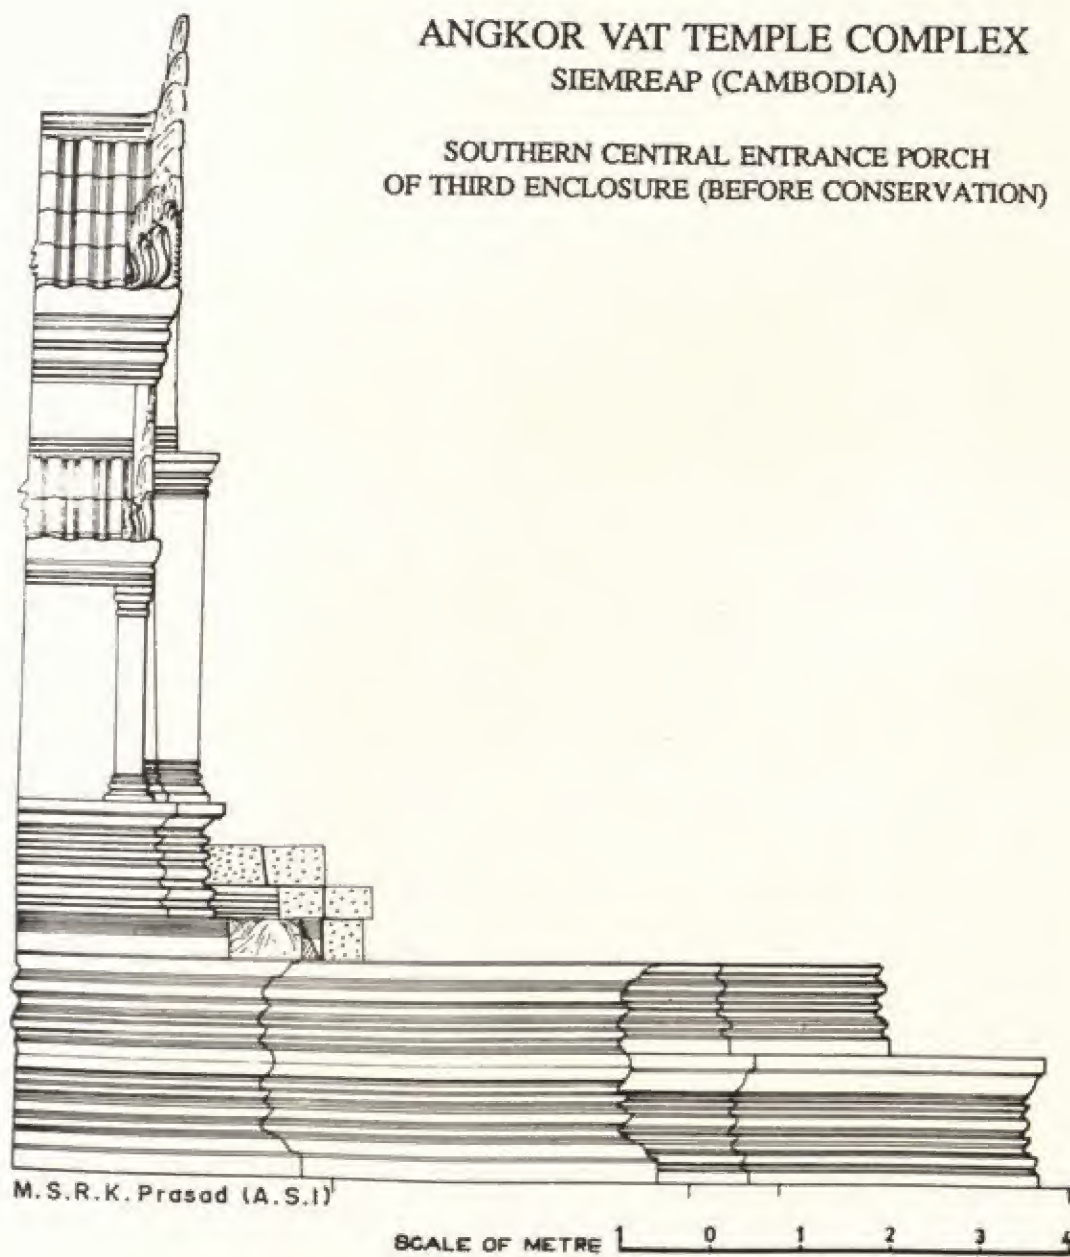
FIG. 5a

SOUTHERN CENTRAL ENTRANCE PORCH
OF THIRD ENCLOSURE (BEFORE CONSERVATION)

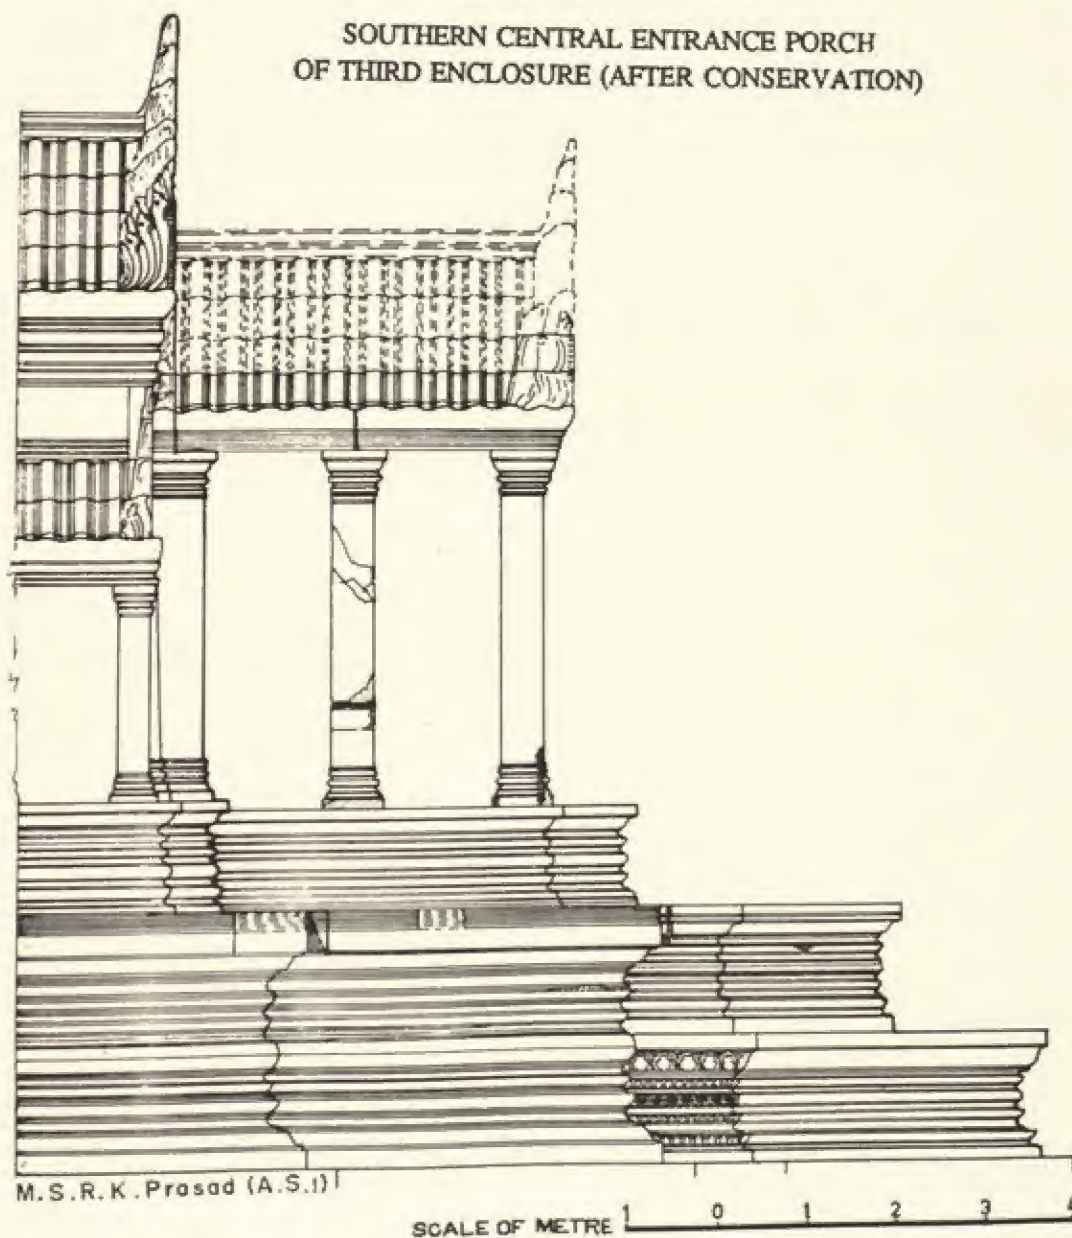
FIG. 5b

SOUTHERN CENTRAL ENTRANCE PORCH
OF THIRD ENCLOSURE (AFTER CONSERVATION)

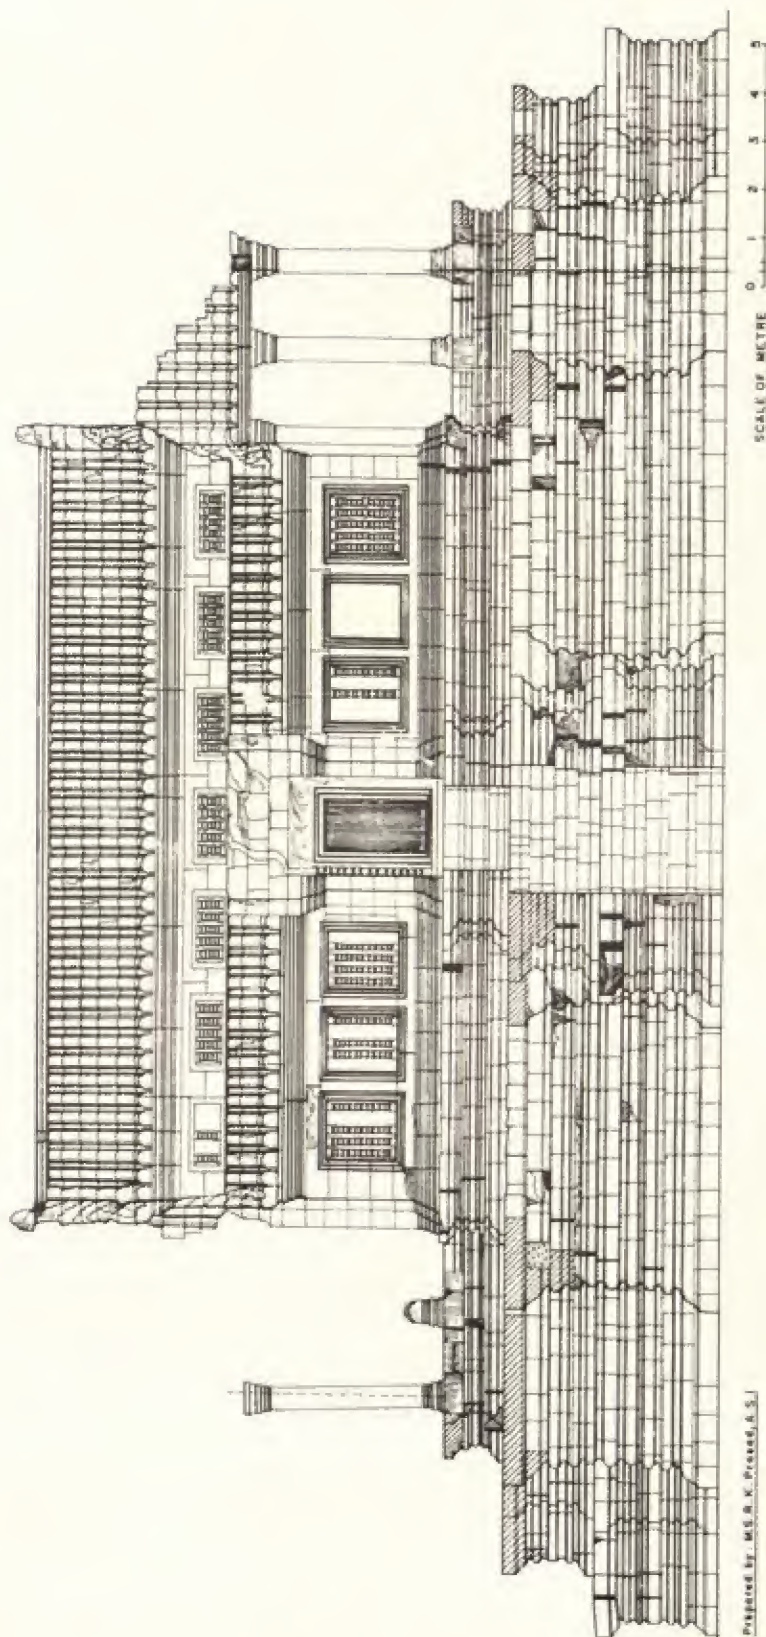
Fig. 10a

ANGKOR VAT TEMPLE COMPLEX
SIEMREAP (CAMBODIA)
NORTHERN LIBRARY BETWEEN SECOND AND THIRD ENCLOSURES
NORTHERN SIDE ELEVATION (BEFORE CONSERVATION)

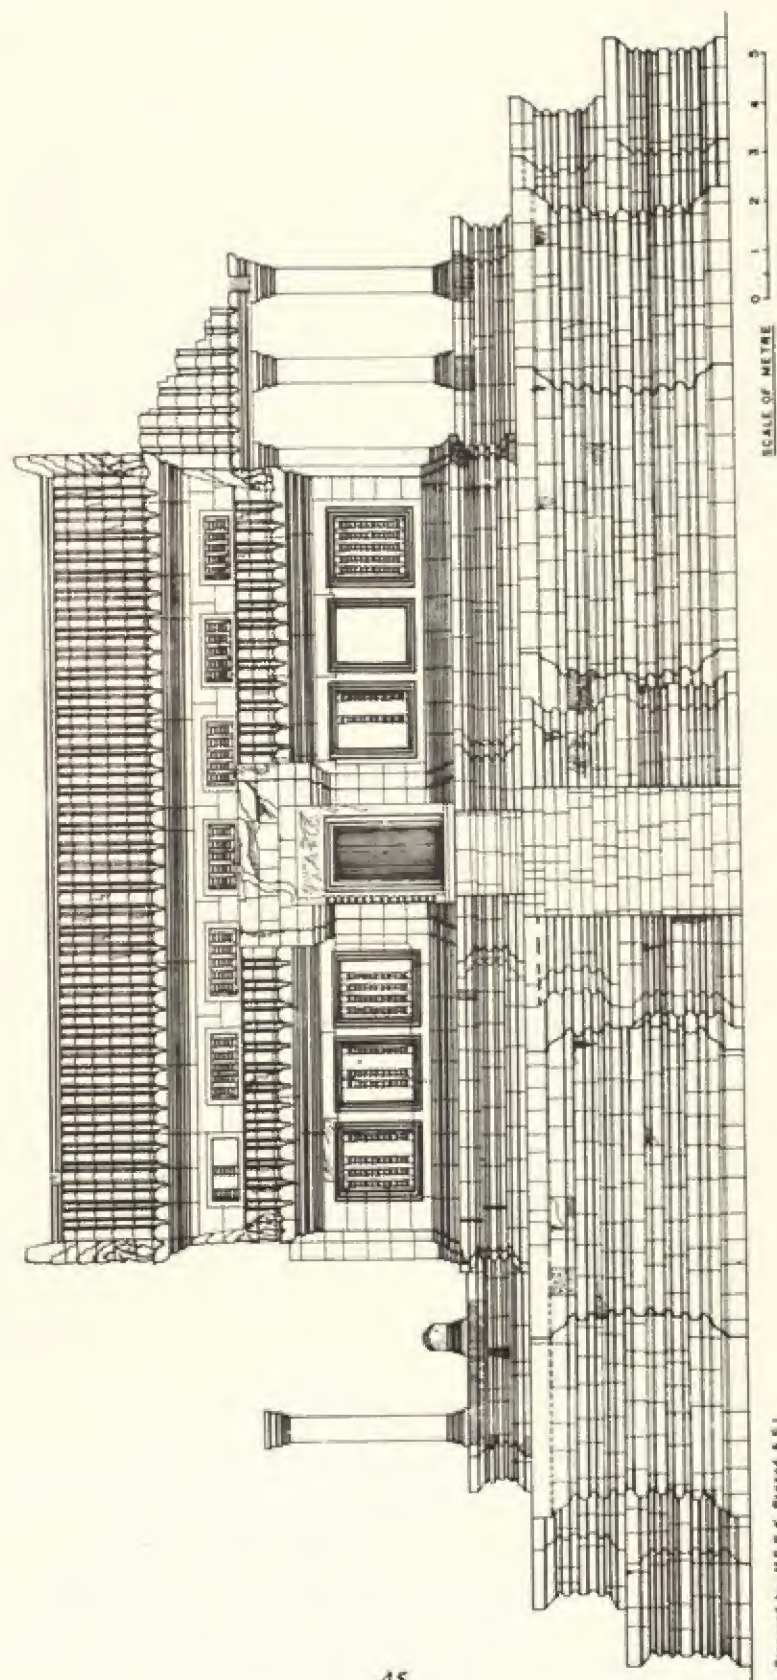
Fig. 10b

ANGKOR VAT TEMPLE COMPLEX
SIEMREAP (CAMBODIA)
NORTHERN LIBRARY BETWEEN SECOND AND THIRD ENCLOSURES
NORTHERN SIDE ELEVATION (AFTER CONSERVATION)

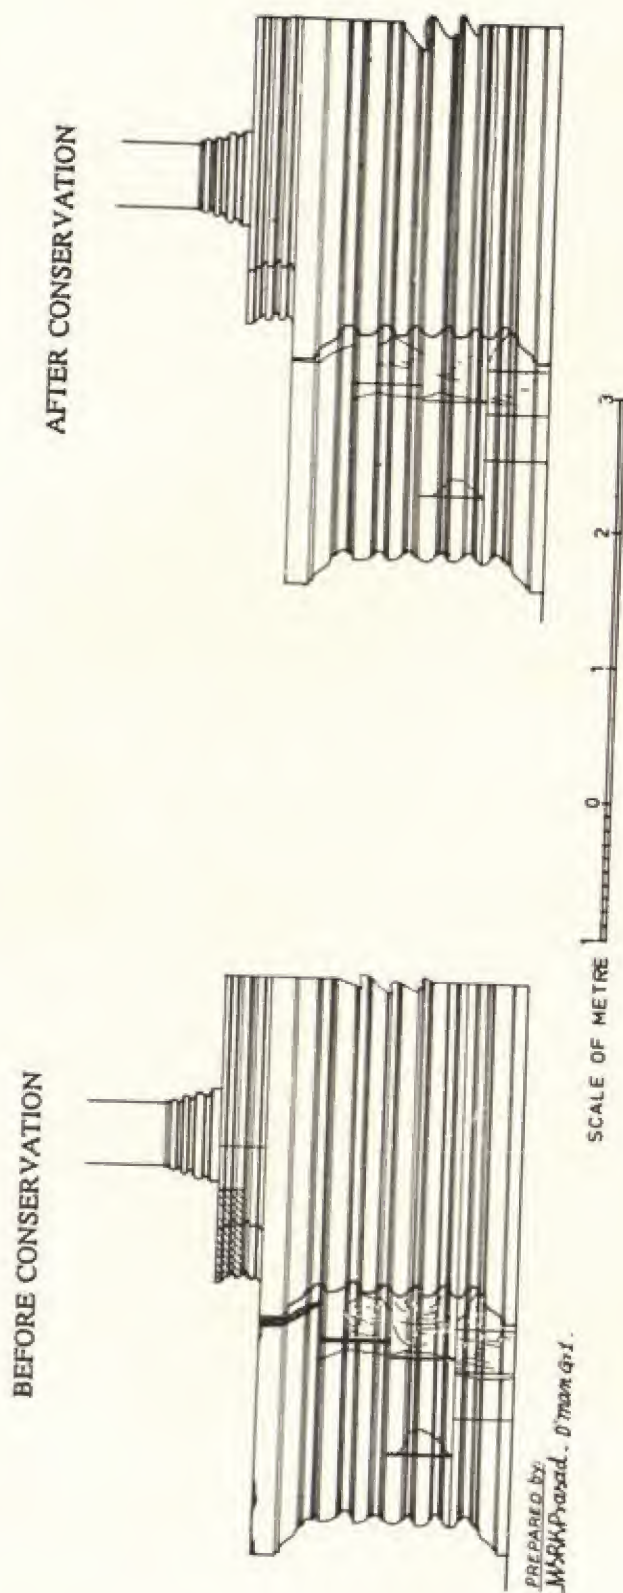
Fig. 14

NORTHERN ENTRANCE PORCH OF ANTE-CHAMBER OF SECOND ENCLOSURE

northern portion was precariously overhanging. The flooring was also dislodged and one pillar was in bad condition and the other was missing. Fortunately, the collapsed architectural members of the superstructure were lying in a heap on the floor of the porch.

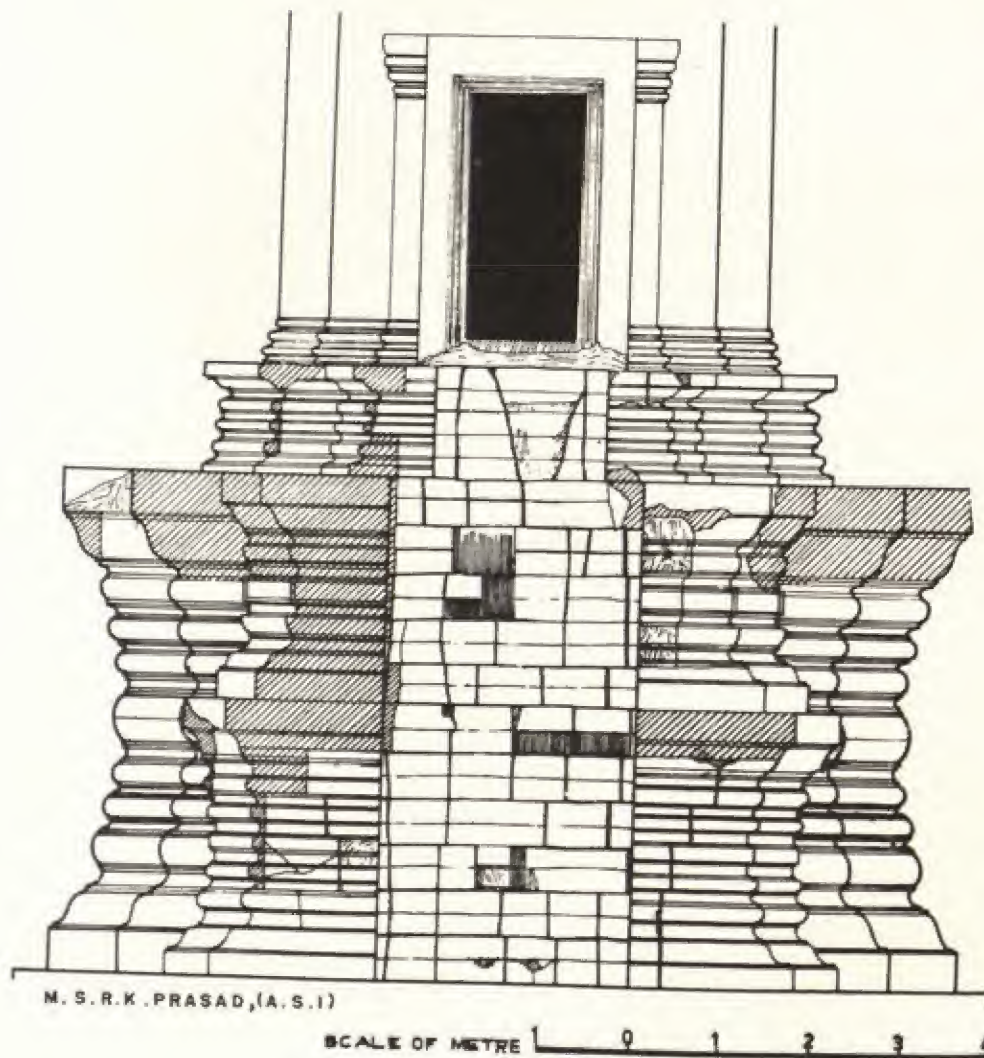
FIG. 15a

EASTERN ENTRANCE AT NORTHERN CORNER
OF SECOND ENCLOSURE (BEFORE CONSERVATION)

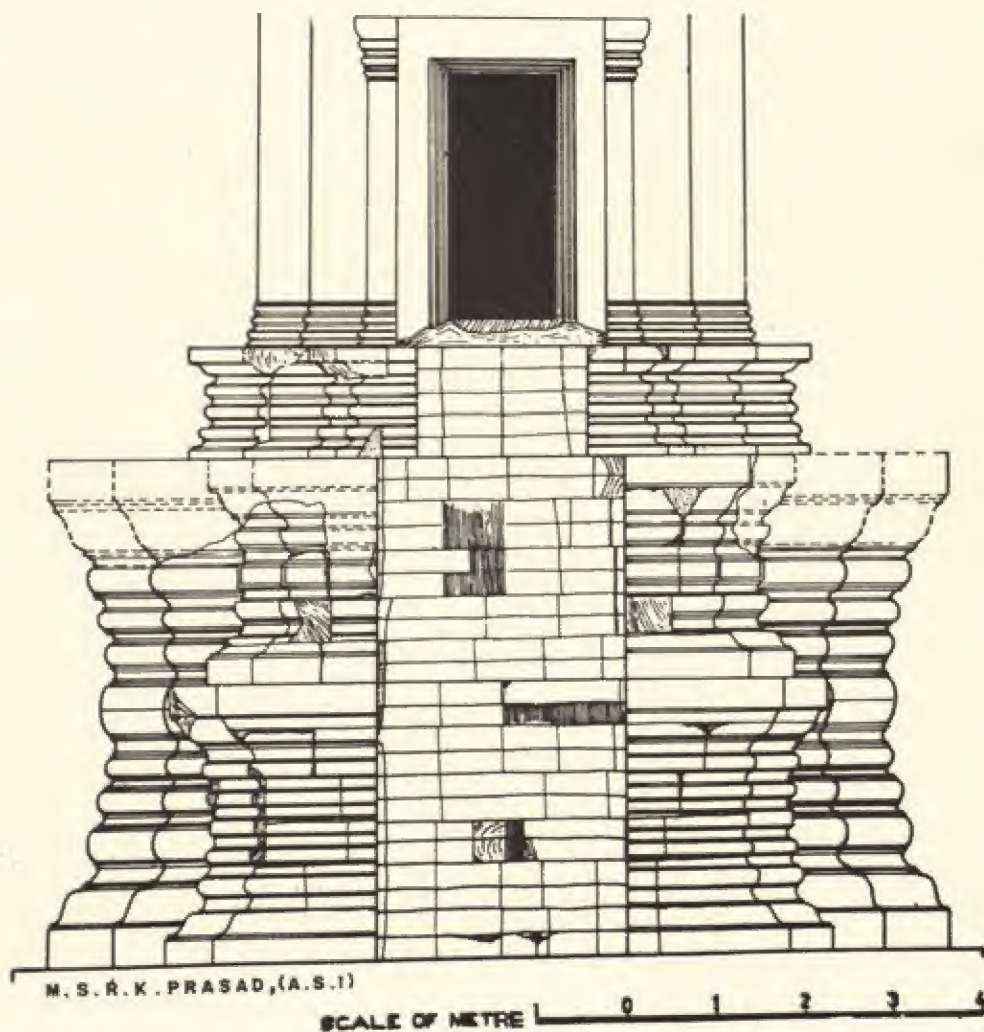
Fig. 15b

EASTERN ENTRANCE AT NORTHERN CORNER
OF SECOND ENCLOSURE (AFTER CONSERVATION)

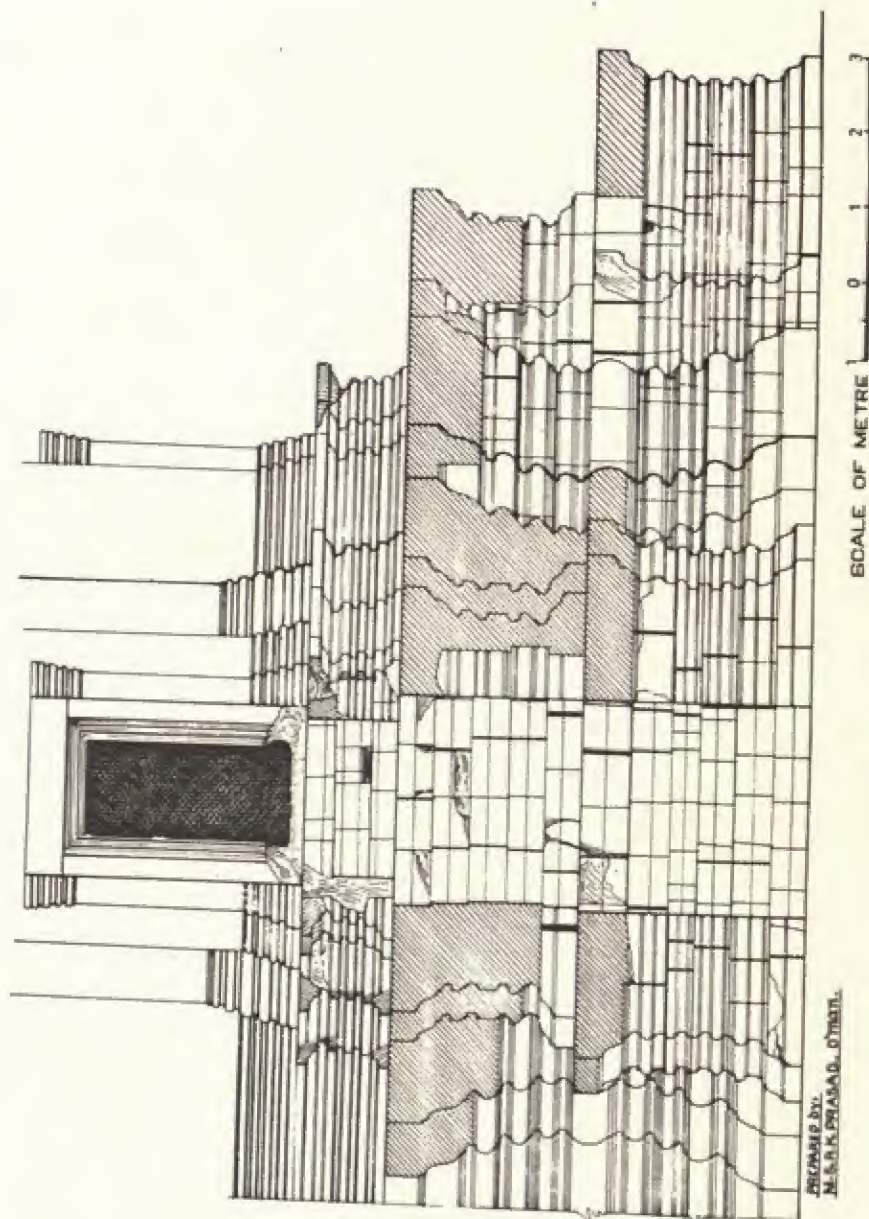
Fig. 19a

WESTERN ENTRANCE AT SOUTHERN CORNER
OF SECOND ENCLOSURE (BEFORE CONSERVATION)

mentioned one. All the dislodged twenty-one (21) stone members were moved into their proper positions by using horizontal jacks and by human efforts. Another nine (9) members which had fallen down from their original positions were hauled up and fixed in their positions (pl. LV). The structure (fig. 16) was watertightened by filling up the gaps and crevices and grouting and pointing of the joints in the masonry.

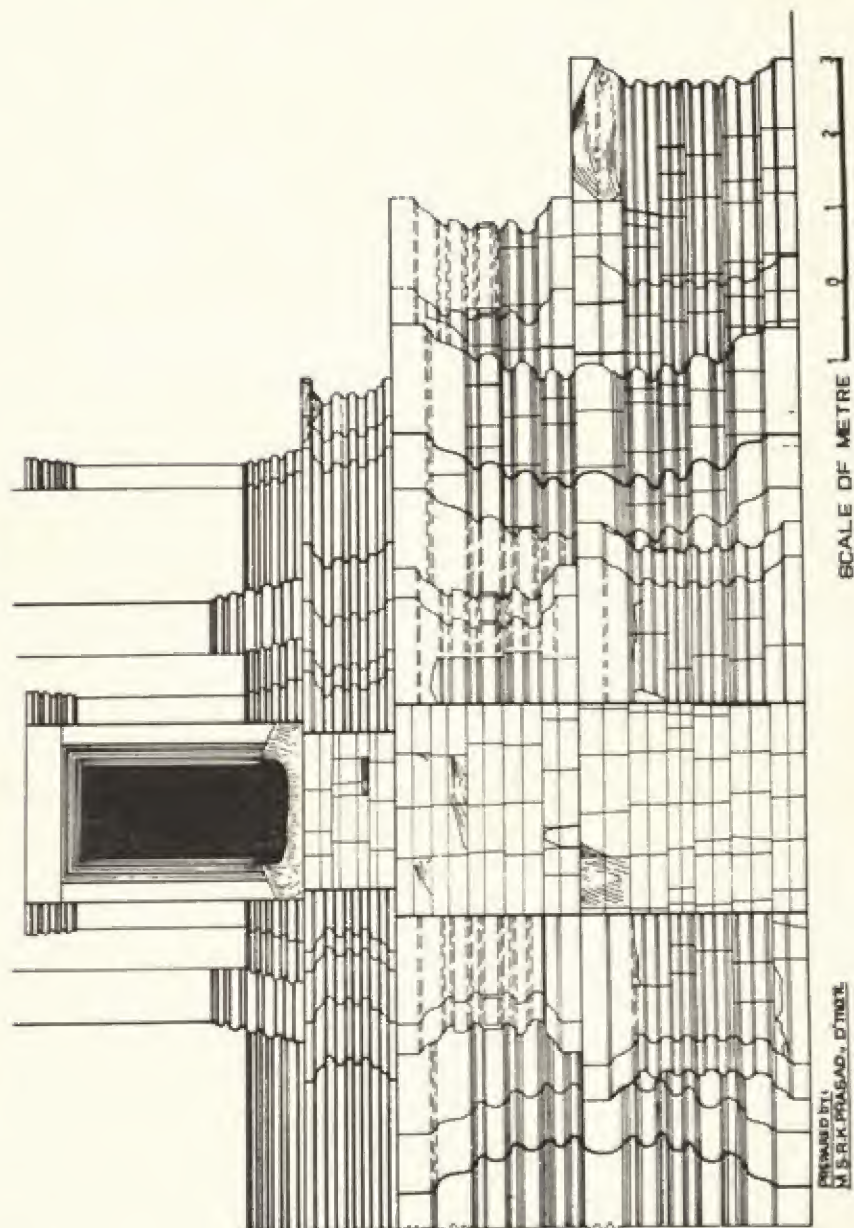
Fig. 19b

ANGKOR VAT TEMPLE COMPLEX
SIEMREAP (CAMBODIA)
WESTERN ENTRANCE AT SOUTHERN CORNER
OF SECOND ENCLOSURE (AFTER CONSERVATION)

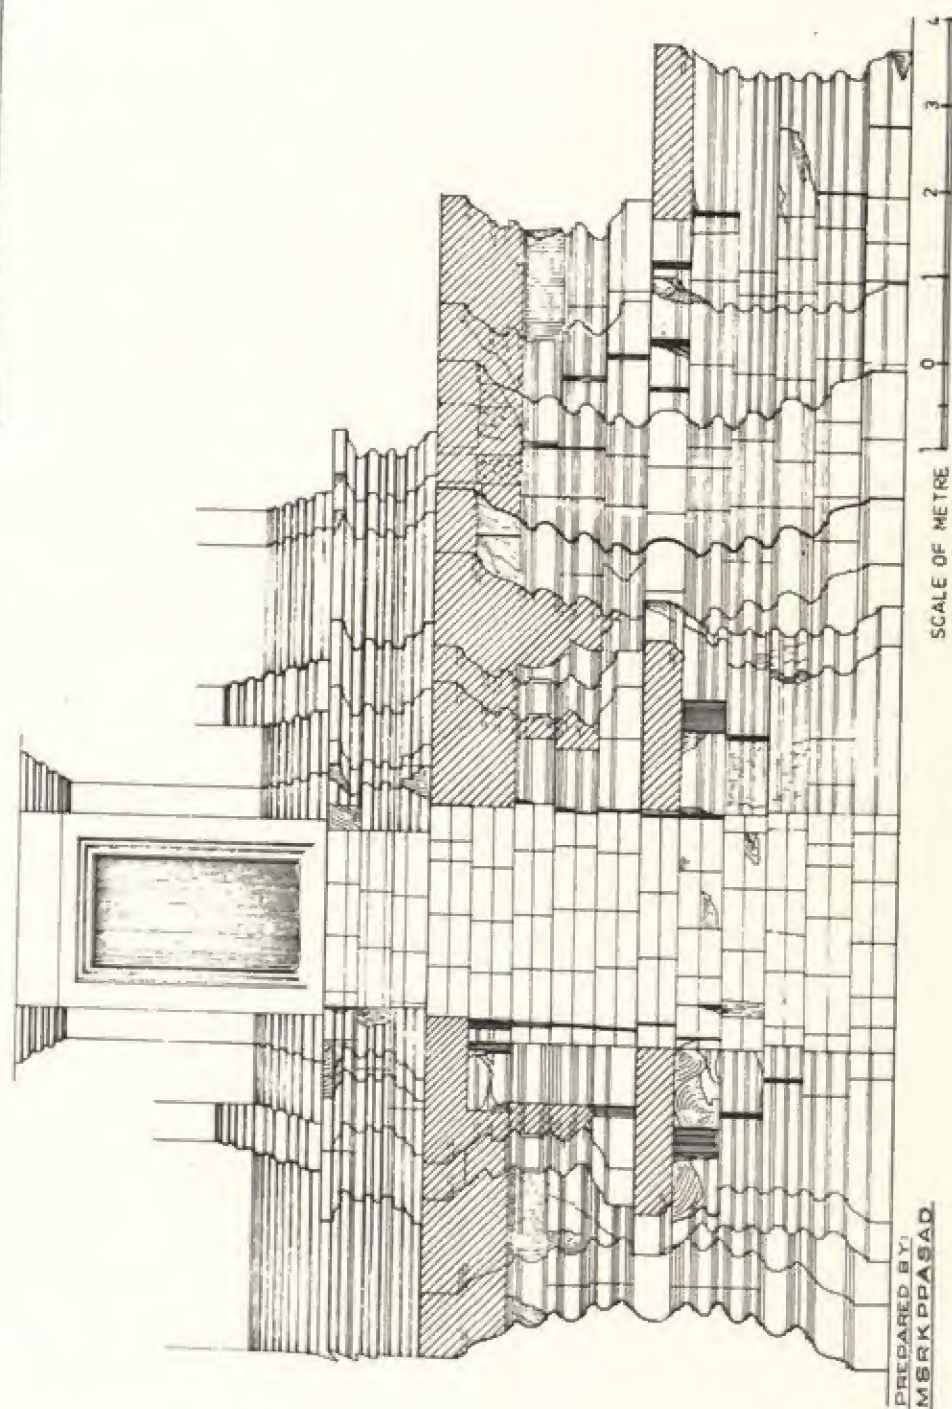
Fig. 21a

NORTHERN ENTRANCE AT WEST CORNER OF SECOND ENCLOSURE

BEFORE CONSERVATION

plinth, balustrades and steps were dismantled and reconstructed as per the original after consolidating the core. While conserving, seventy-four (74) architectural members were dismantled and reset. Another four (4) members which were lying on the ground were identified and hauled up and fixed in their original positions in the structure (pl. LXI). Then the structure was thoroughly watertightened (fig. 21).

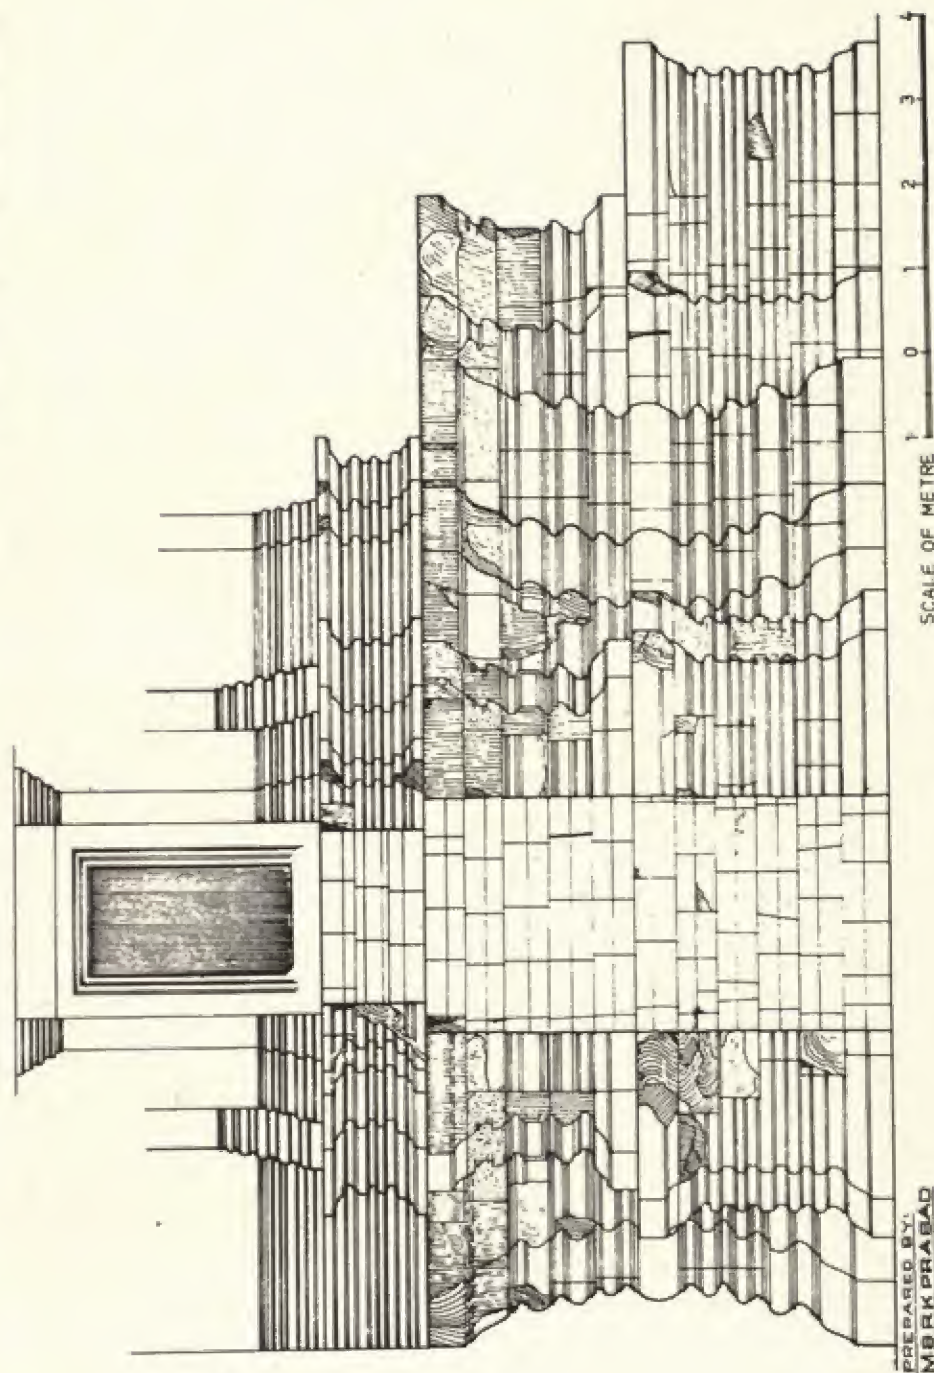
Fig. 21b

NORTHERN ENTRANCE AT WEST CORNER OF SECOND ENCLOSURE

AFTER CONSERVATION

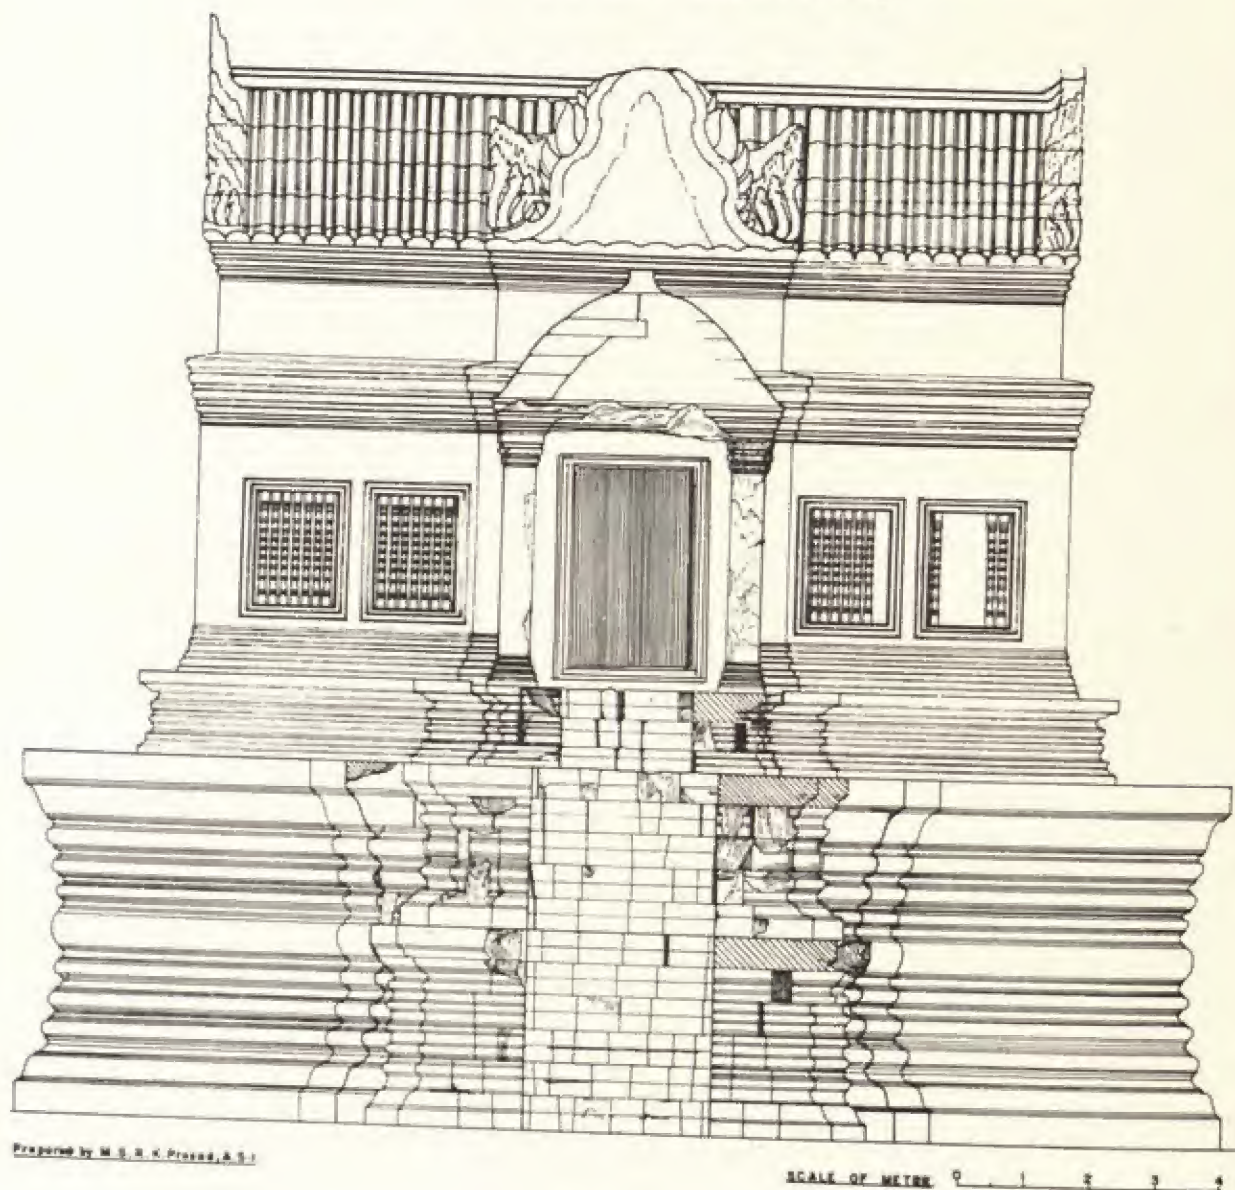
FIG. 22a

NORTHERN CENTRAL ENTRANCE PORCH OF SECOND ENCLOSURE
(BEFORE CONSERVATION)

let alone smaller ones, had been dislodged and were overhanging precariously. However, most concerning was that the supporting stones of the members with cantilever action were weathering fast. Crevices and gaps had formed which allowed rain water to flow into the fabric of the structure and damage the stones. The architectural members of the tower were being pulverised due to water action. The leakage in the towers was so much that all the rain water was flowing into the structure. The vegetation was growing freely over them. The birds and bats had made their nests in the crevices and gaps. Therefore, the conservation of the towers was of high priority.

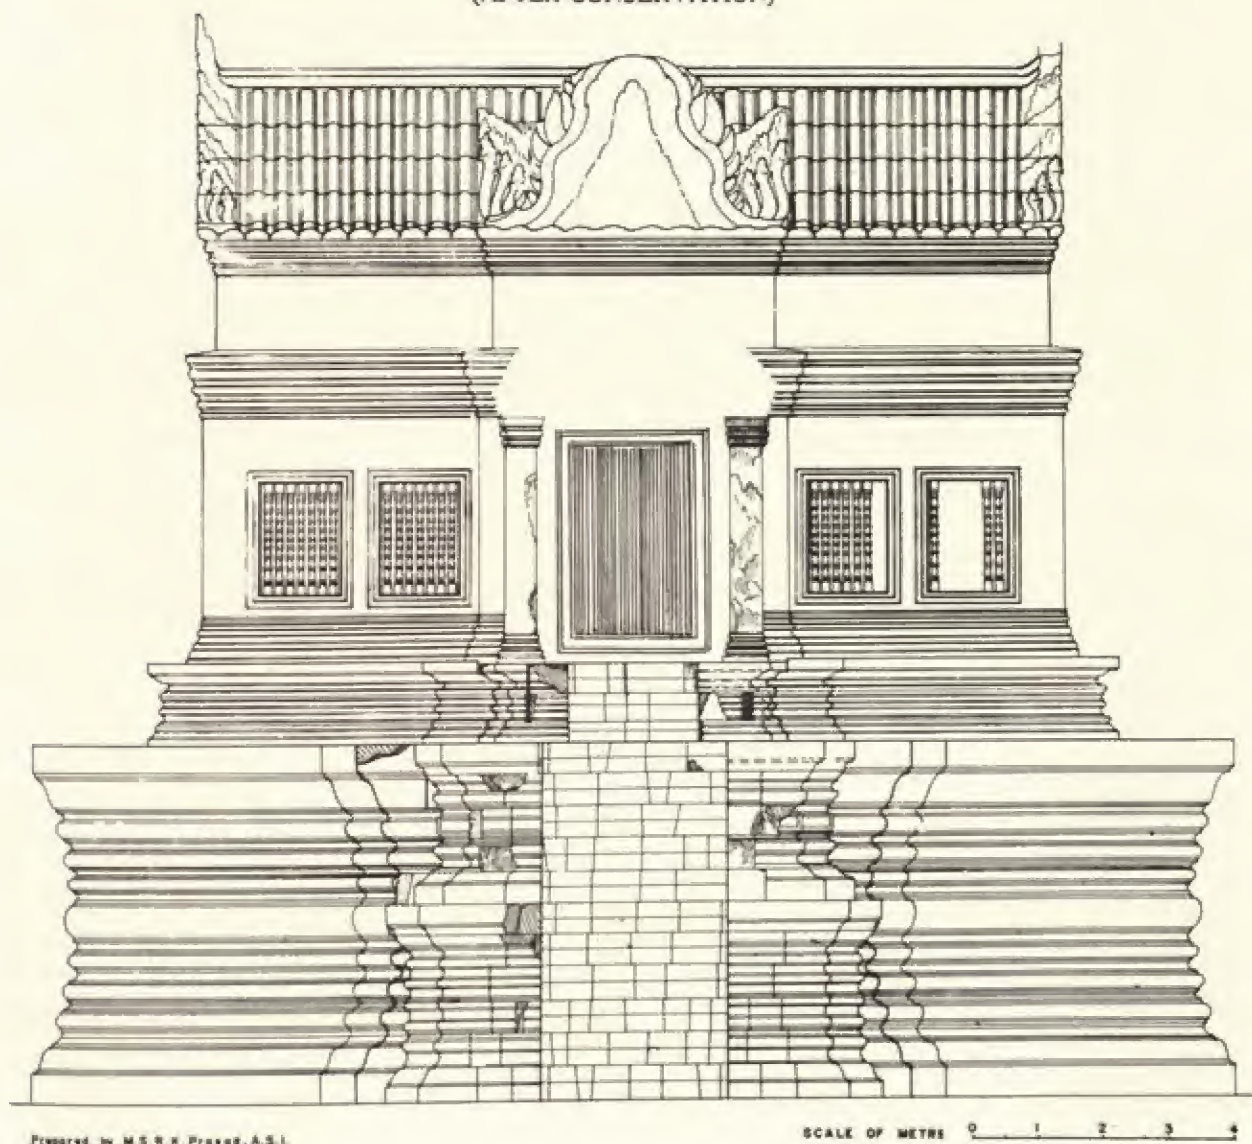
FIG. 22b

NORTHERN CENTRAL ENTRANCE PORCH OF SECOND ENCLOSURE
(AFTER CONSERVATION)
